# CERTIFICATE OF LOCATION OF GOVERNMENT CORNER

EAST QUARTER Corner of Section 30, Township 115 N, Range 38 W, 5<sup>th</sup> P.M.

STATE OF MINNESOTA, County of YELLOW MEDICINE

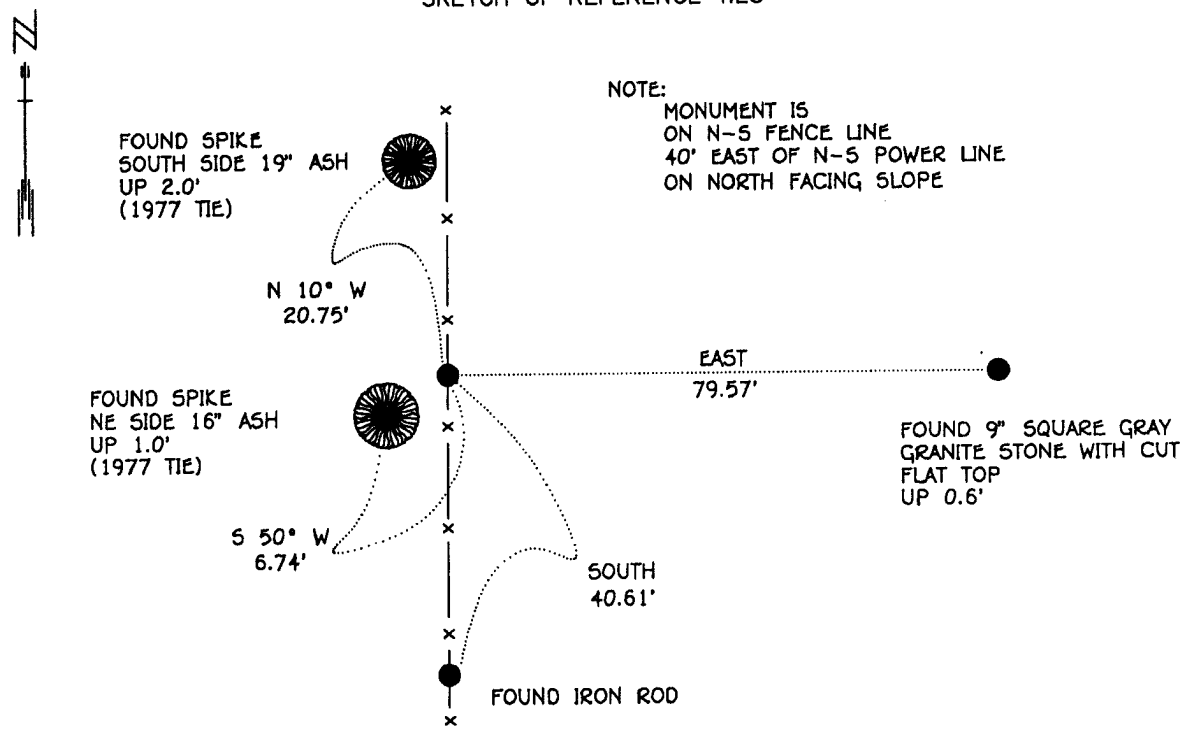
### SKETCH OF REFERENCE TIES

- On 6-21-95 found a 1/2" INSIDE DIAMETER IRON PIPE WITH A PLASTIC CAP  
DATE STAMPED "RLS #10396", UP 0.3'
- left monument as found,  lowered monument,  removed monument (explain)
- On \_\_\_\_\_ Placed a \_\_\_\_\_  
DATE

1995 June 21, DNR Bureau of Engineering found the ½" diameter iron pipe set for corner in 1977. Searched for and found record ties as shown on sketch of reference ties. The iron pipe was found to be:

2681.10 feet from the northeast corner of Section 31
